# Hot Dip Galvanizing

The best protection inside and out

**galvanizers**  
ASSOCIATION OF AUSTRALIA

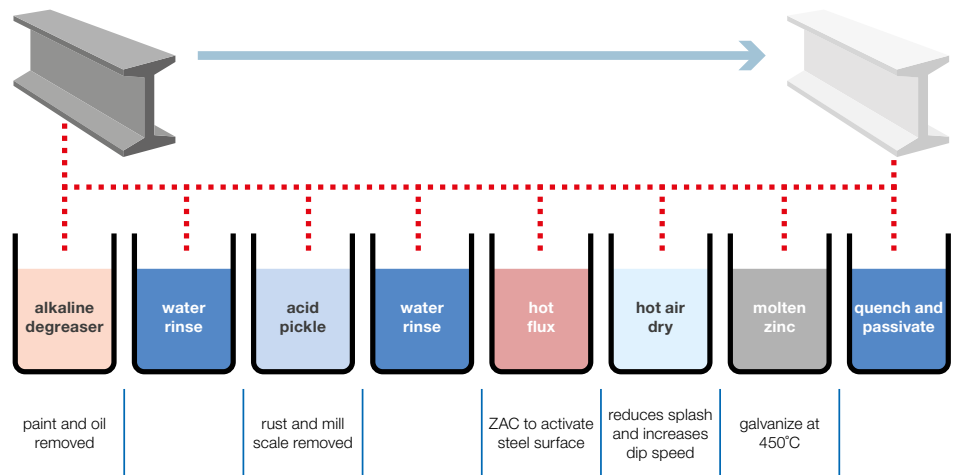
## Hot dip galvanizing process

The hot dip galvanizing process starts by suspending steel articles and dipping them into a series of cleaning baths. Once cleaned, the steel is lowered at an angle into a bath of molten zinc. Immersing the steel on an angle allows air to escape from vented tubular shapes or pockets that may be within the design and permits the molten zinc to displace the air. The steel reacts with the molten zinc to form the galvanized coating. After being withdrawn from the zinc, the final step in most hot dip galvanizing processes is a quench and passivate to promote passivation of the zinc surface.

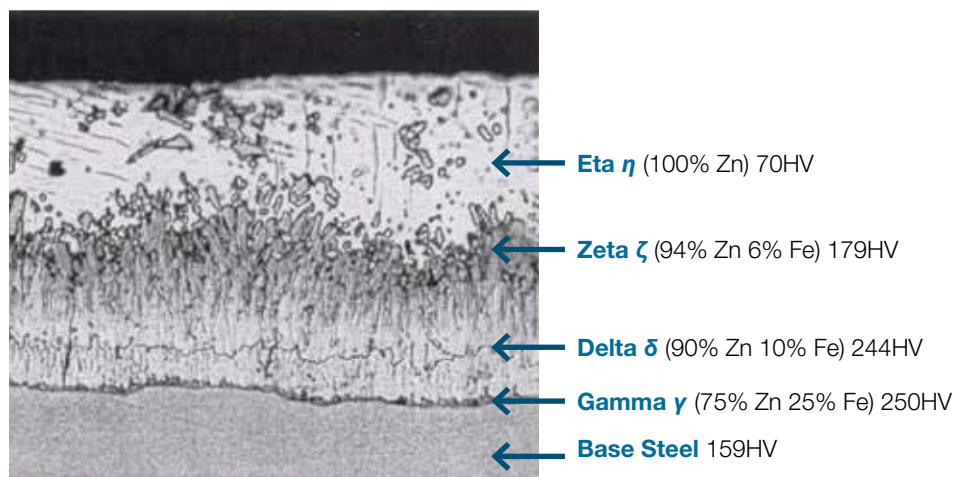
## Structure of coating

The formation of the galvanized coating on the steel surface is a metallurgical reaction, where the zinc and steel combine to form a series of hard intermetallic layers. The outer layer is, typically, 100% zinc which covers the surface after withdrawal from the molten zinc bath.

The gamma, delta and zeta alloy layers are all harder than the base steel they are metallurgically bonded to, which gives hot dip galvanizing its great abrasion resistance.

The galvanizing process naturally produces coatings on the corners and edges which are at least as thick as the coating on the rest of the article. As the reaction between iron and zinc is a diffusion reaction, the crystalline structure of the coating forms perpendicular to the steel surface.

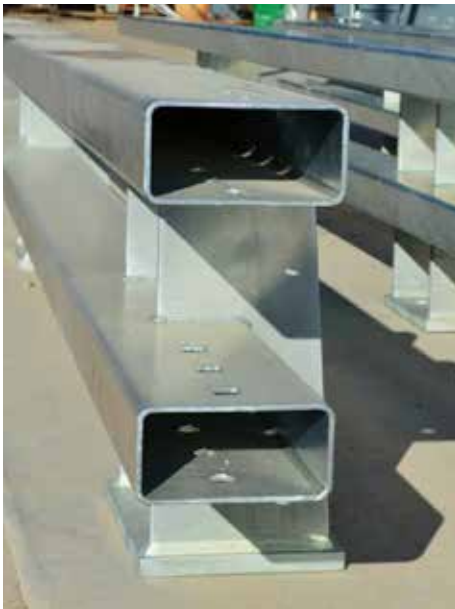
Only hot dip galvanizing can provide barrier protection to this bridge rail, inside and out.

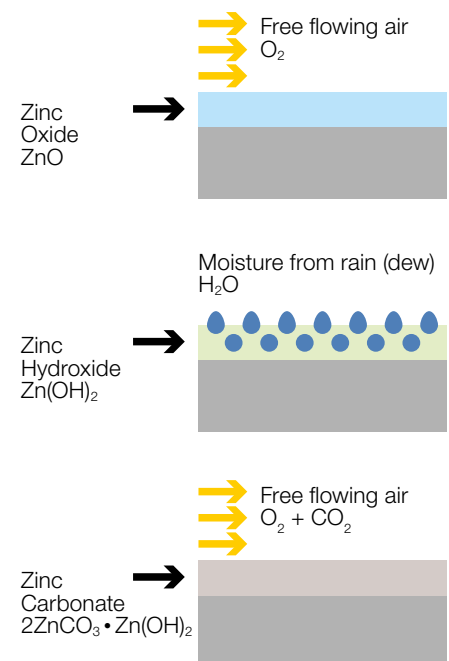
Above: The zinc patina begins its development with exposure to oxygen in the atmosphere. Moisture from rain or humid air reacts with this layer to form zinc hydroxide. This layer then reacts with carbon dioxide present in the atmosphere to form the tightly adherent, insoluble zinc patina.

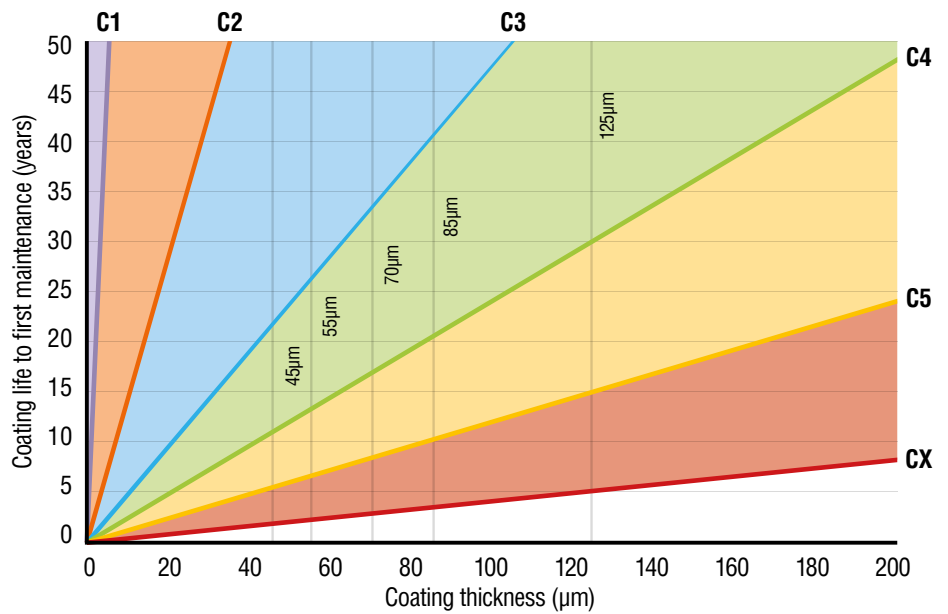
The chart shows that steel with an initial coating thickness of 85µm in a C4 corrosivity zone will have an expected life to first maintenance of 20 – 40 years.

The life of a hot dip galvanized coating is (to a first approximation) proportional to its thickness, which is normally a function of the article's steel thickness.
