THE CONCEPT OF LIFE CYCLE COSTING FOR THE CORROSION PROTECTION OF STEEL

May 2013, updated December 2015

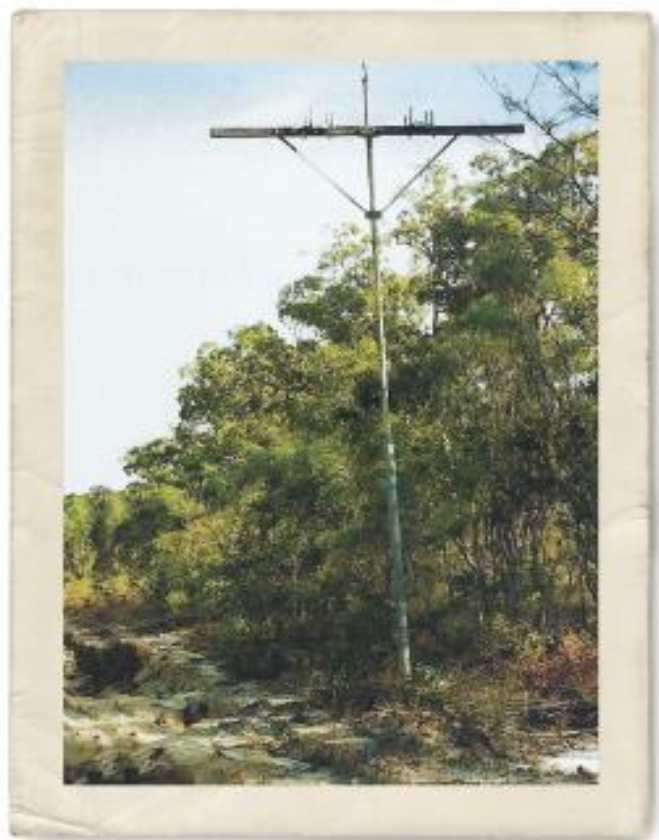
The original 1883 overland telegraph pole system was thought to have another 200 years of life left in the galvanizing when it was decommissioned in 1997.

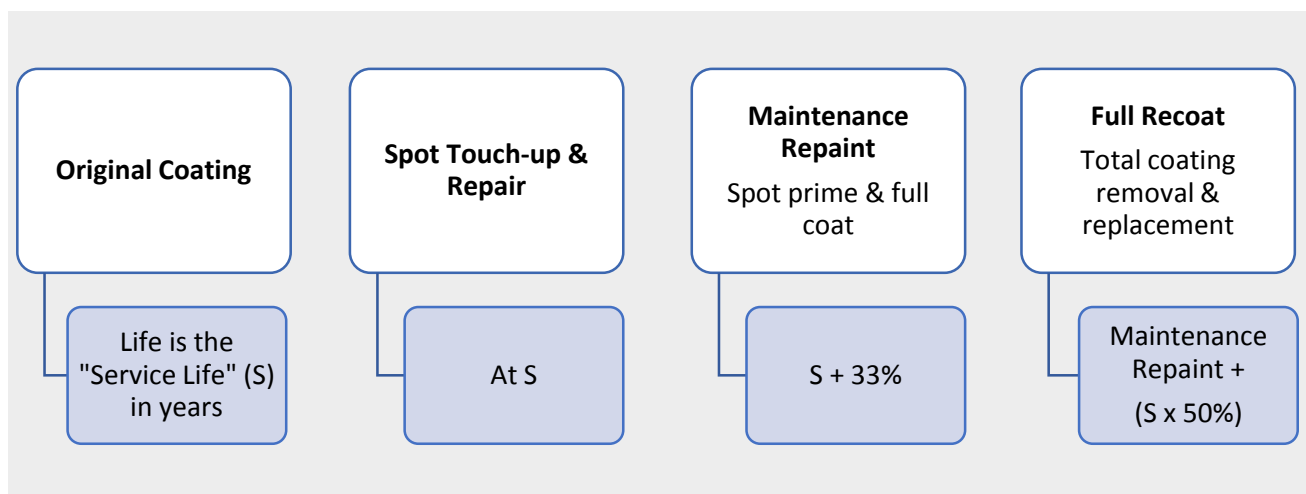
Practical decisions on the level of maintenance required should be based on the results of a maintenance program, including regular assessment of the coating thickness, adhesion, substrate condition and the extent and distribution of any corrosion. A typical paint maintenance process is shown below.

For example, if the service life was 15 years, then the spot touch up and repair would be planned at year 15, the maintenance repaint planned at year 20, and full repaint required at year 28.

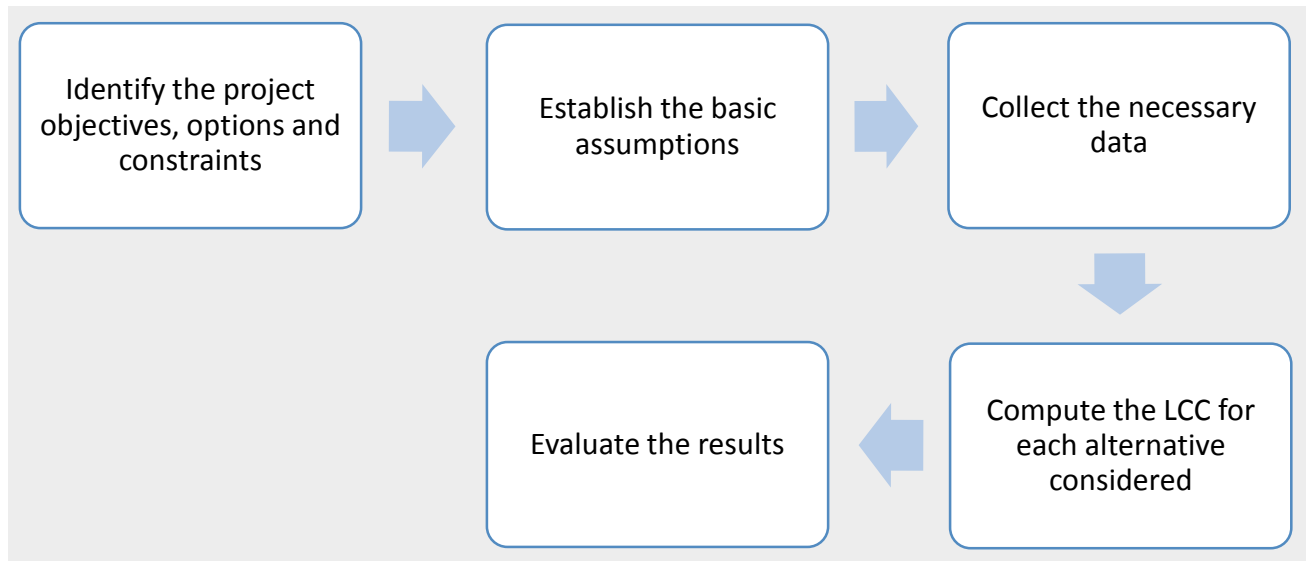
Shown below are the five basic steps in performing a LCC calculation.

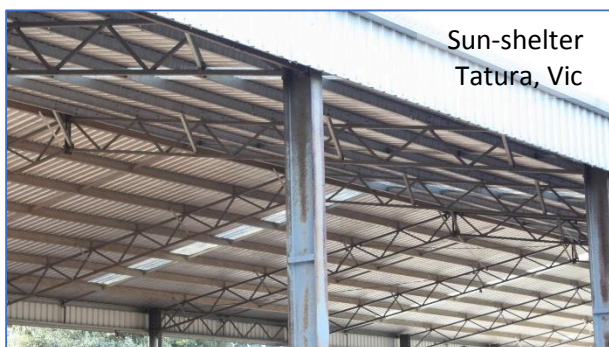
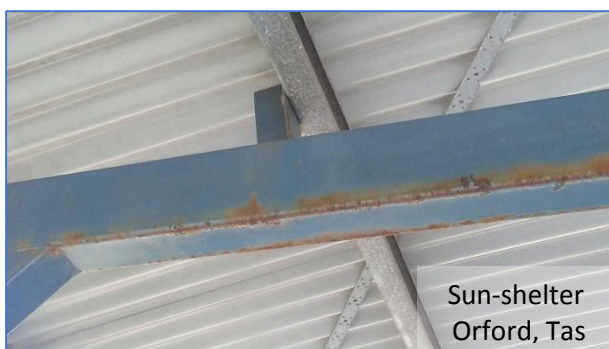
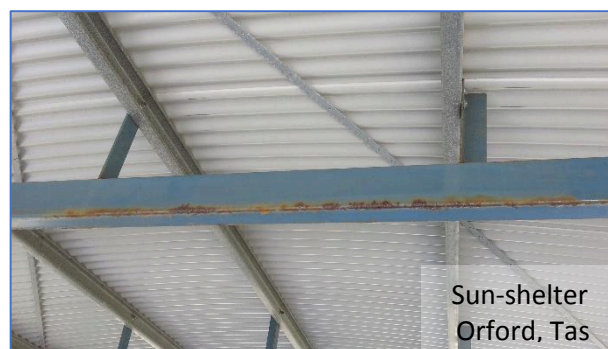
The above pictures show early failure of the paint system in a C2/C3 environment well before any red rust on the galvanized components. The owners of these assets will need early intervention to extend the asset life to their original expectations.

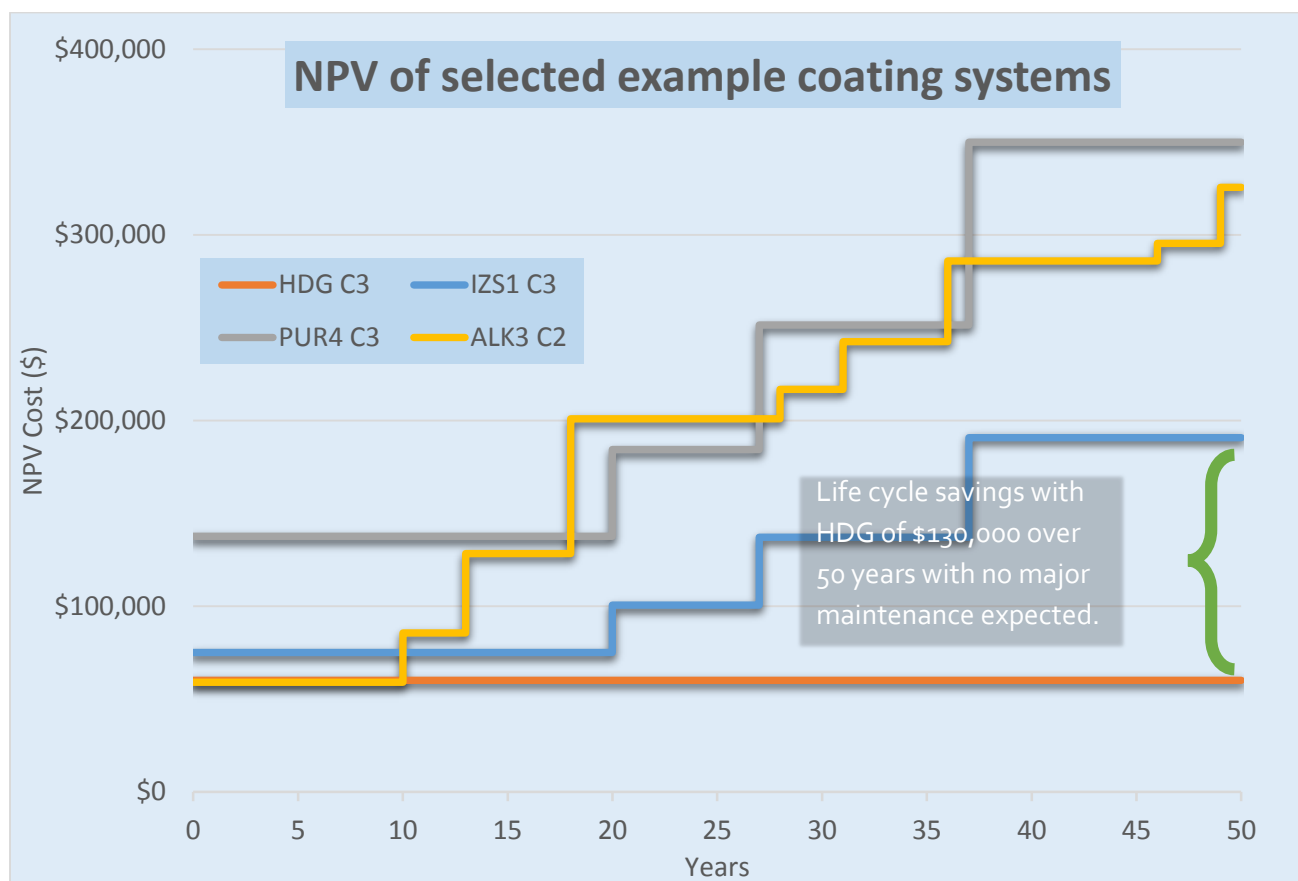
The following graph shows how the maintenance cycle affects the overall cost of a system to an asset owner, and the initial cost is often not the driver of the total cost.

Coating System	Initial Cost		Net Present Value (Life Cycle Cost)		AEAC	HDG Lifetime Savings Ratio
	\$ per m ²	\$ Total	\$ per m ²	\$ Total	\$ per m ²	
AS/NZS 4680 HDG600	\$24.00	\$60,000	\$24.00	\$60,000	\$1.74	---
AS/NZS 2312.1 IZS1	\$30.00	\$75,000	\$76.28	\$190,705	\$5.53	3.2
AS/NZS 2312.1 PUR4	\$55.00	\$137,500	\$139.85	\$349,629	\$10.13	5.8
AS/NZS 2312.1 ALK3	\$23.60	\$59,000	\$130.24	\$325,597	\$9.44	5.4

For this project, the life cycle costing shows the **lifetime savings using HDG are more than 3 times** that of the single coat inorganic zinc silicate system in a C3 environment, even though the cost of each system was initially similar. For an internal application in a C2 environment, **HDG offers nearly 6 times the lifetime savings** compared to a simple 2-coat alkyd system often used in warehouse designs.
